FACTORS AFFECTING SIGN RETROREFLECTIVITY

Final Report

SR 514

Oregon Department of Transportation

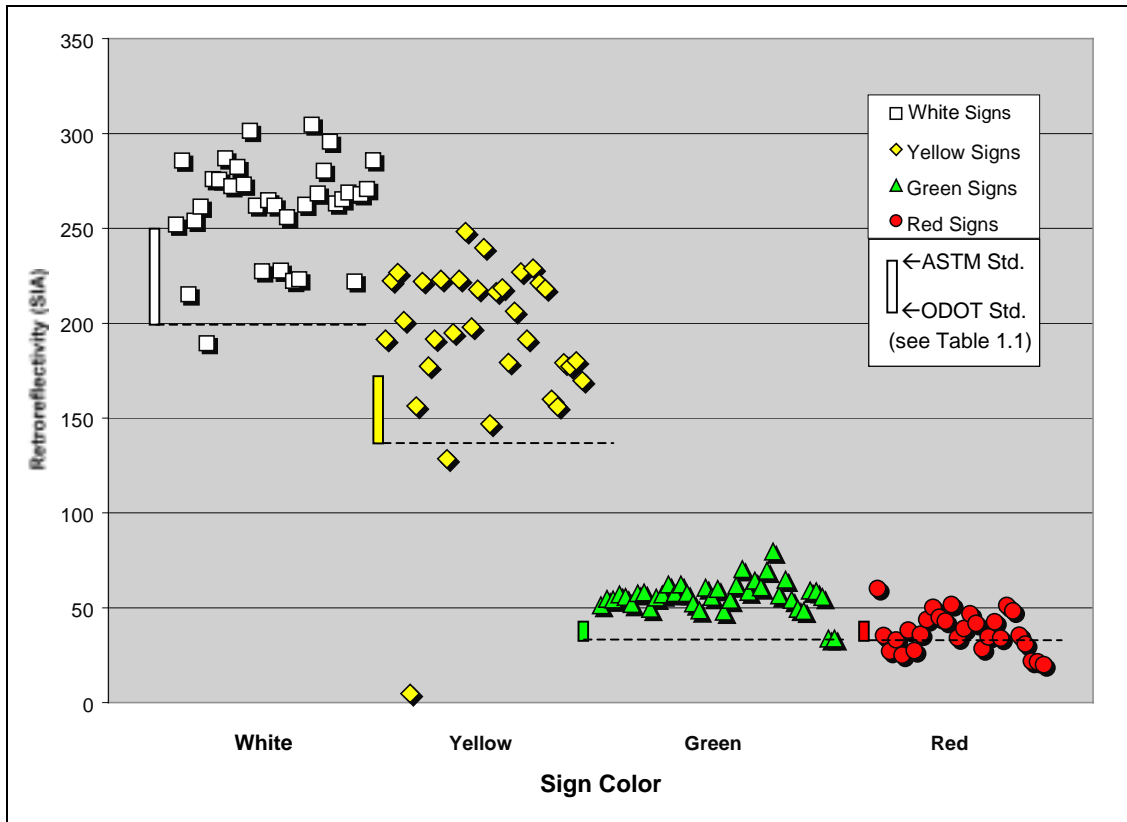
Figure 3.1: Retroreflectivity values for signs of different colors

Figure 3.1 shows the average SIA values for all signs. The retroreflectivity of white signs was the highest, with average readings ranging from 189 to 305. The average readings for yellow signs were somewhat lower, ranging from 129 to 248 (with an outlying data point at 5). The average readings for green signs ranged from 34 to 80. The SIA values for red signs ranged from 20 to 60.

For comparison purposes, Figure 3.1 also uses bars to show the minimum retroreflectivity standards established for each sign color (Table 1.1). The lower end of the range corresponds to the ODOT minimum standard at ten years of service. The upper end of the range corresponds to the ASTM standard. As Figure 3.1 shows, the overall levels of retroreflectivity measured for different sign colors were generally in the same order of magnitude as the ASTM standards. Virtually all of the readings were above the ODOT standard, and most were above the ASTM standard, with the exception of red signs.

Table 3.2 shows the comparison between the ODOT minimum values at ten years of service and the average readings by color from the sample of 137 signs. The red signs yielded the lowest average value, exceeding the ODOT standard by only 3%. The average values for signs of other colors exceeded the ODOT standard by 31% to 56% (with the exception of one data point).

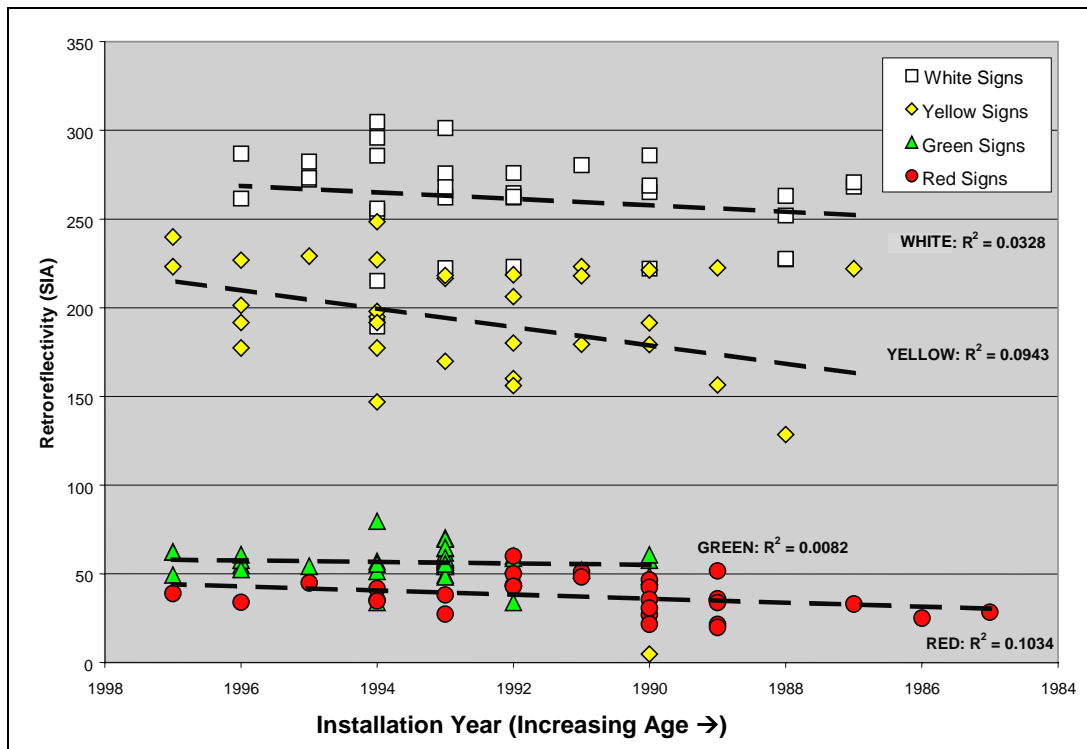
Figure 3.2: Retroreflectivity and sign age

One might expect that as a sign ages, its retroreflectivity might decline, due to the effects of weather or other environmental conditions. To determine the relationship between sign age and retroreflectivity, the average SIA value for each sign was plotted against the installation year (ranging from 1985 to 1997). Figure 3.2 shows the results for each sign color. The trend lines show little relationship, however, between the age of signs and their retroreflectivity values.

Two factors may help explain the apparent lack of relationship. First, the age range of the signs may not have been great enough to provide a complete picture of sign performance over time. Second, the installation year data may not have been entirely reliable. A more carefully controlled investigation covering a greater time span would be needed to further explore whether any relationship exists between sign retroreflectivity and sign age.

High average retroreflectivity values (compared to the ODOT minimums), coupled with the lack of any apparent relationship between retroreflectivity and age over a twelve-year period, suggests that sign retroreflectivity in the mid-Willamette Valley may not change enough over time to warrant the use of age as a factor in planning for sign replacement.

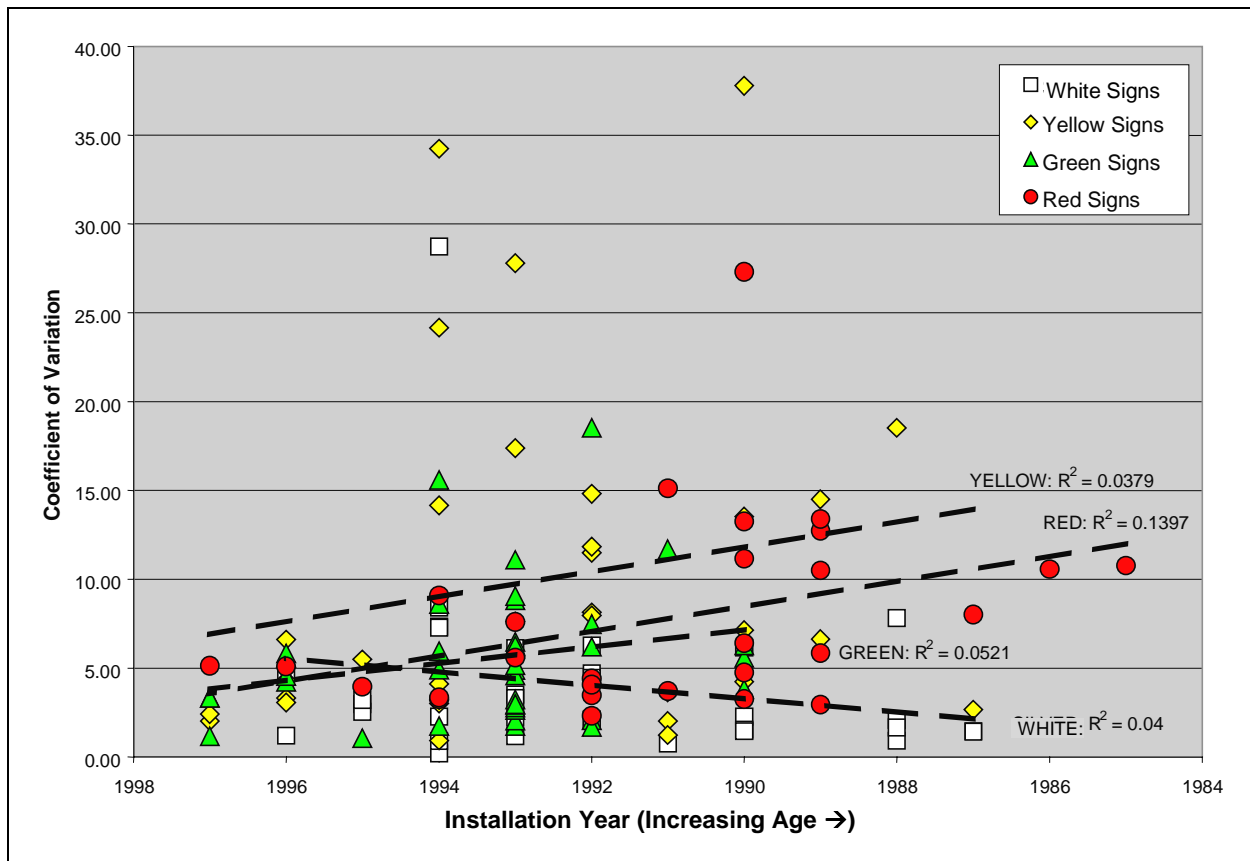
Figure 3.3: Coefficient of Variation and sign age

As a sign ages, it is possible that the variability of its retroreflectivity could increase, due to surface abrasion from wind-blown dust and precipitation. Figure 3.3 shows the relationship between sign age and the Coefficient of Variation for each sign color. The analysis shows, however, that there is no clear relationship between the variability of sign retroreflectivity readings and age.

It seems likely that even if the level of retroreflectivity is not related to sign age, the variability might increase with age, as the clear plastic surface of a sign suffers the effects of abrasion from windblown dust, dirt and precipitation. The analysis of data in this study, however, shows no such relationship. It may be that more time is needed for the effects of sign weathering to have a measurable impact. The twelve-year sign age span may not have been long enough to detect weathering effects, at least in the mid-Willamette Valley environment.

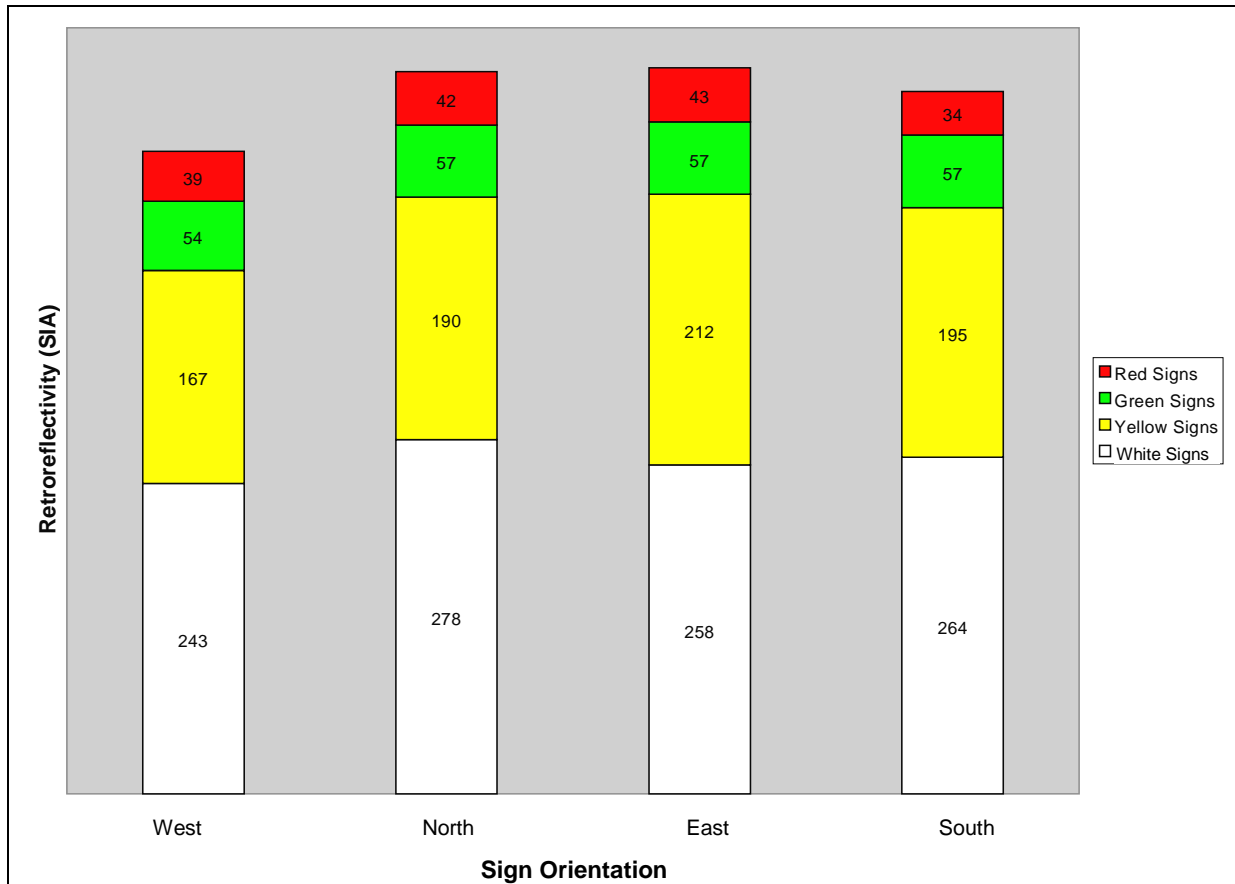
Figure 3.4: Retroreflectivity and sign orientation

Signs with greater exposure to solar radiation or to windblown dust and precipitation might be expected to lose retroreflectivity sooner than more sheltered signs. Given the latitude of the area (approx. 45° North) and the predominant weather patterns, west-facing and south-facing signs could thus be expected to show lower levels of retroreflectivity. Figure 3.4 shows the relationship between the physical orientation of signs and their retroreflectivity. Although there was no strong trend, it appears that west-facing signs may tend to have slightly lower retroreflectivity than those facing other directions. Lower retroreflectivity for west-facing signs was recorded for three of the four sign colors – white, yellow and green. Among red signs, retroreflectivity values tended to be lowest among south-facing signs.

In the analysis of the relationship between retroreflectivity and sign orientation, the findings suggest that west-facing and south-facing signs may have more retroreflectivity variability, although degradation in the average levels of retroreflectivity is not so evident. Thus weathering effects may indeed be a factor that at some point needs to be a sign maintenance program consideration.

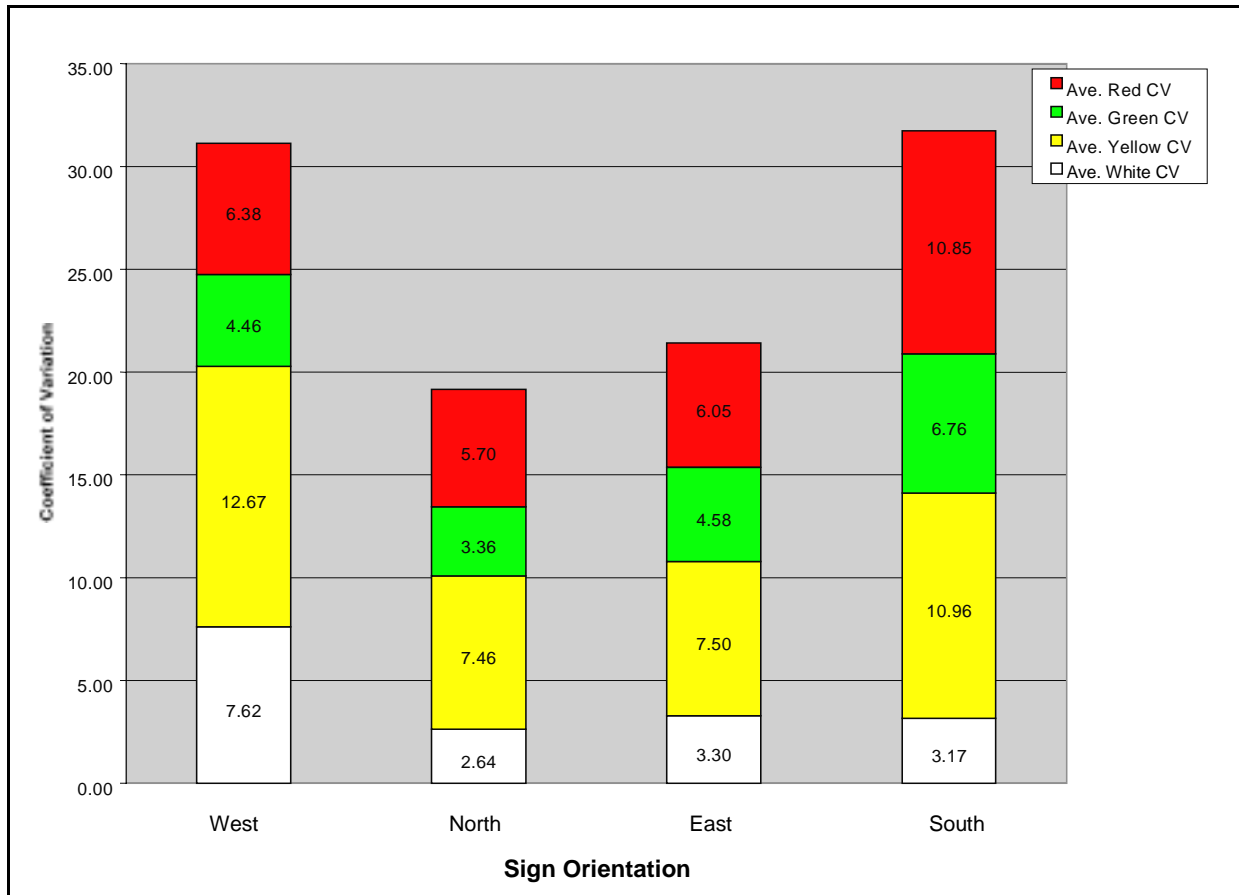
Figure 3.5: Coefficient of Variation and sign orientation

The retroreflectivity variability (Coefficient of Variation) was also examined for each sign orientation. Figure 3.5 shows that, overall, west-facing and south-facing signs tended to have higher variability of readings. Yellow and white signs facing west showed higher variability than those facing other directions; red and green signs facing south showed higher variability than those facing other directions. Using retroreflectivity variability as an indicator of sign condition, this finding suggests greater weathering effects among west-facing and south-facing signs, probably due to abrasion from windblown dust, dirt and precipitation. The magnitude of these effects, however, is not great enough to produce average retroreflectivity values below the ODOT minimum standards.

During repeat field measurements to verify the second-round data, it was found that in about 19% of the cases the sign orientation had been incorrectly recorded. Thus the reliability of the field data on sign orientation is somewhat questionable. More carefully controlled additional research would be necessary to validate the finding that west-facing and south-facing signs show greater variability in retroreflectivity.
